TURBOMACHINERY BALANCING CONSIDERATIONS

John R. East

Hickham Industries, Incorporated

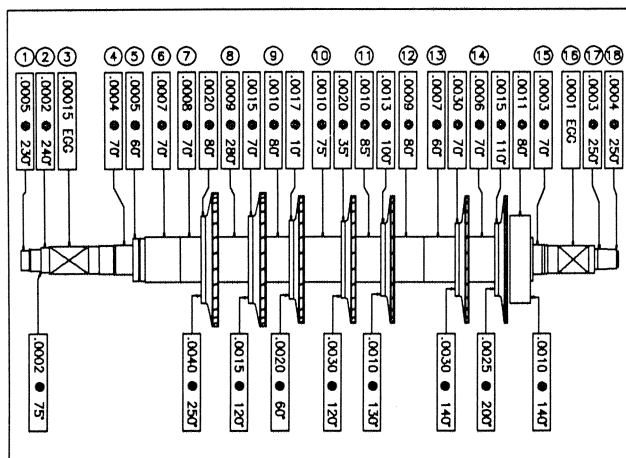
An example is shown in Figure 1 of properly documented runouts on a compressor rotor. To the untrained eye, the runouts may seem low, and consequently, insignificant. In fact, the runouts are well within most OEM specifications, and most likely, meet most inspectors' expectations. A closer look reveals that impeller number one is most likely cocked on the shaft, since the phase of the runouts on the suction eye OD and face are 170 degrees apart. Further, the large differences in phase across the bearing journals suggest a bowed shaft.

Figure 1. Proper Runout Documentation.

The basic centerline shape of the rotor is shown in Figure 2. This plot was made using the runout information shown in Figure 1, in the following manner:

- Layout the distances between runout points to scale on graph paper. (Numbers 1-18 in Figure 1 correspond to 1-18 in Figure 2).
- Take either the sine (or cosine) of the phase angle, then multiply the result times the amount of runout. (For example, point number 1 is 0.5 mils @ 230 degrees; $\sin 230 \text{ degrees} = -0.766$; $-0.766 \times 0.5 \text{ mils} = -0.38$).
- Plot the result of the preceding step for each runout point of interest.

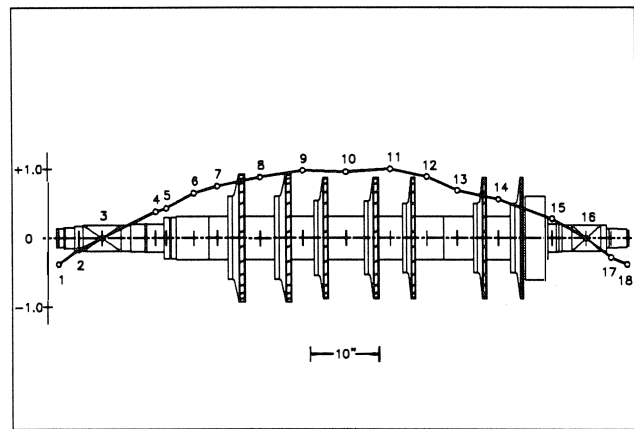
The final plot will be indicative of the centerline shape of the rotor, however, this method does not provide a plot that is representative of the actual amount of centerline deflection. This kind of information is very helpful during rotor inspections and can help identify areas of excessive shaft stresses as well as bows.

Figure 2. Plot of Rotor Centerline Shape.

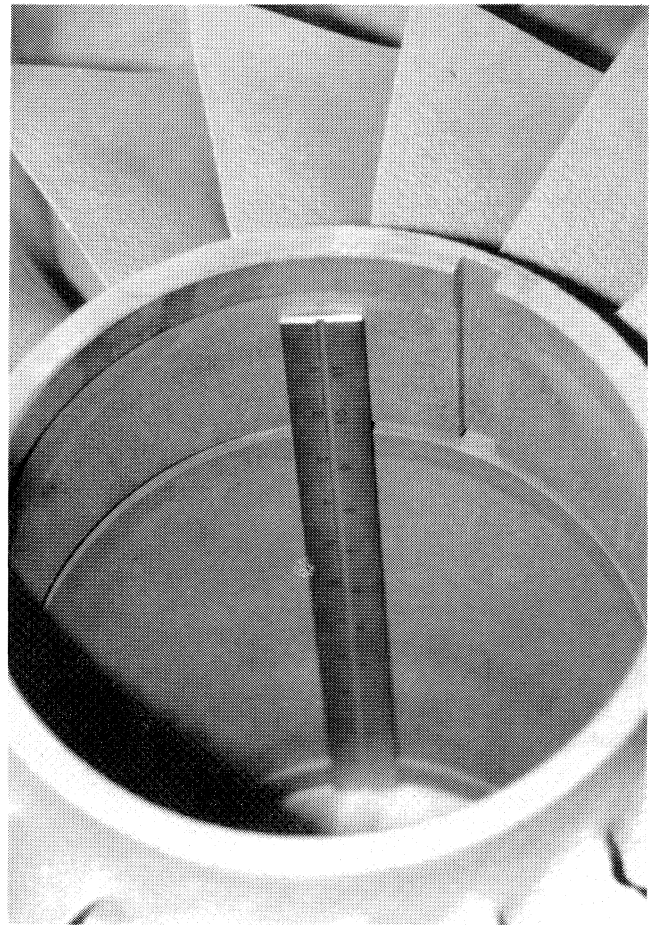
Consider an impeller with a 13¼ in long, 7½ in diameter bore, that has an interference fit of 0.002 in/in diameter (Figure 3) To install this impeller, it must be heated to provide approximately 0.023 in of bore expansion, or 472°F above ambient shop temperature. At this temperature, the bore length of the impeller will expand by approximately 0.040 in. As the impeller cools and the bore contracts, tremendous stresses are built up in the components by the uniform shrink fits across the bore length. These stresses commonly result in excessive centerline deflections of the shaft. If the stresses are ignored and the components are “balanced,” the result is too often a rotor with unacceptable levels of vibration. As the rotor enters the first bending critical, the stresses will typically relieve somewhat, and the rotor takes on an entirely different shape than it had when it was balanced. When this happens, large unbalances are induced while the rotor is in the critical, resulting in very high vibration that may be catastrophic in nature.

Figure 3. Compressor Impeller with Bore L/D > 0.75.

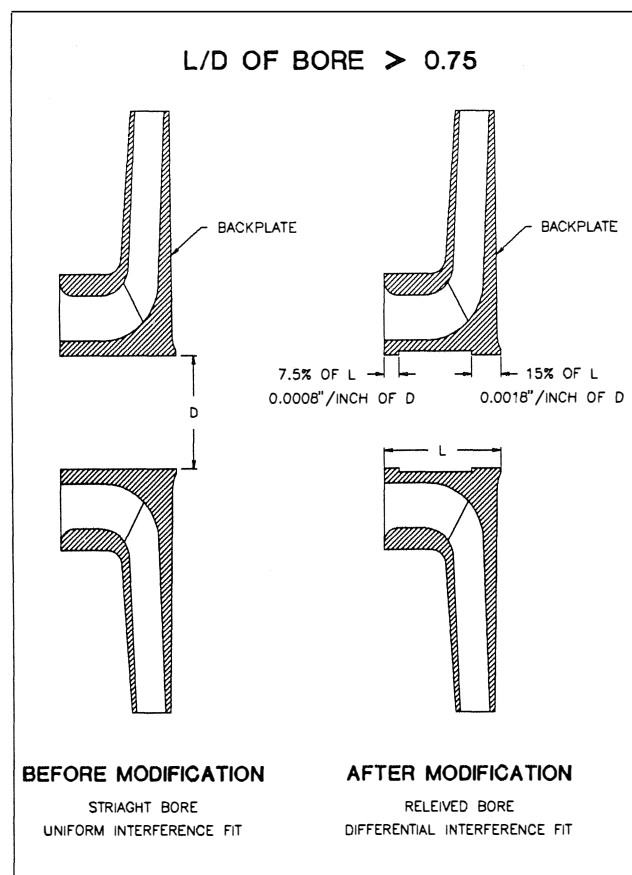
With some designs, it is impossible to cure this problem, however, much can be done to alleviate it (Figure 4). First of all, it must be realized that most modern compressor impellers require an interference fit of 0.0015 in to 0.002 in/in of diameter on the backplate (discharge) side due to centrifugal forces at speed (depending on impeller diameter and speed). However, the suction side of the typical closed impeller design will normally require an interference of only 0.00075 in - 0.001 in/in diameter at most. When the L/D ratio of the impeller bore is greater than 0.75, the following steps are recommended to alleviate excessive rotor stresses:

- Machine a relieved area in the center of the bore, approximately 0.010 in per side, leaving land fit areas at each end of the bore.
- The length of the land fit on the discharge side should be approximately 15 percent of the bore length, while the suction side land should be approximately 7.5 percent of the bore length.
- previously stated. This results in a significant differential fit, which allows a great portion of the inherent stresses to relieve during stacking.
- Record phase related runouts on the face and OD of the suction eye before removing from the boring mill. Runout of the impeller after mounting on the mandrel or the shaft should be within 0.001 in TIR of that recorded in the boring mill, accounting for all phase differences.
- Stack the impeller on the shaft vertically, and allow it to grab the shaft while resting against the spacer sleeve or shoulder. Never

Figure 4. Modification of Impeller Bores to Reduce Stresses.

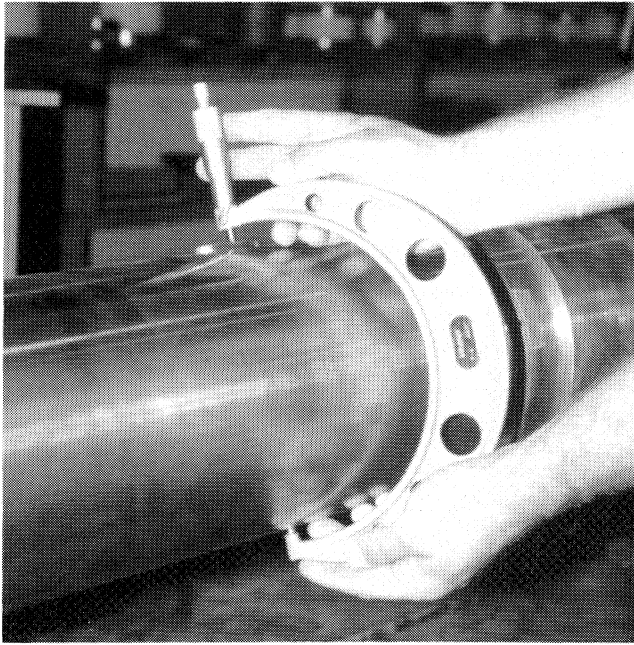
To check key clearance, install the key in the keyway of the shaft and measure across the shaft diameter to the top of the key with an outside micrometer (Figure 5). Then, measure from the top of the keyway in the bore, across the bore to the other side with an inside micrometer (Figure 6). Add to the ID measurement the amount of interference fit, then subtract from this total the OD measurement taken off the shaft. It is very important to have some top clearance (0.004 in to 0.006 in) to prevent the installed component from hanging on the key when installed and, therefore, causing undue stresses. The one step that many fail to do is to allow for the amount of interference fit. The measurement from the opposite side of the wheel bore to the top of the keyway will increase by the amount of the interference when installed.

Figure 5. Measurement of Key In Shaft Dimension.

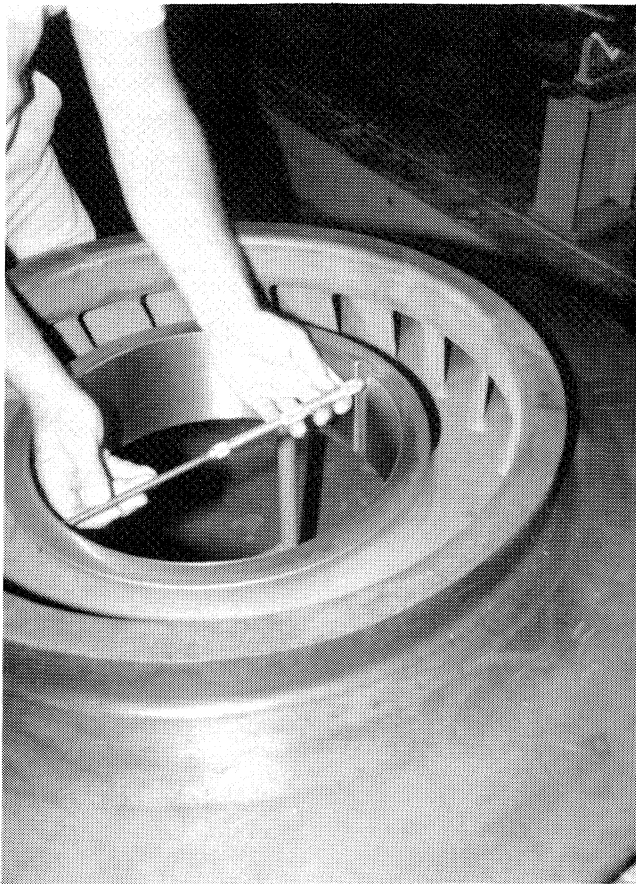
Figure 6. Measurement of Keyway and Bore Dimension.

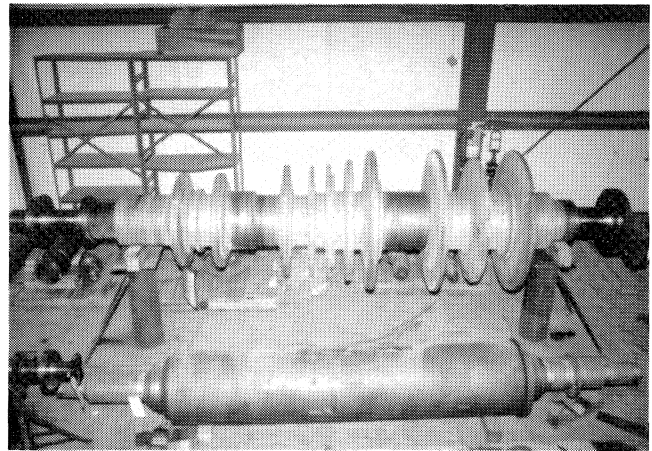
The author was once involved (after the fact!) in such a case. An 11000 lb nine stage steam turbine (Figure 7) had run for quite a few years at low vibration levels. The decision was made to pull the upper case half during a scheduled turnaround to repair leaking steam seals. But once the lid was removed, there sat the rotor just begging to be “check balanced,” so the maintenance people couldn’t stand it! They had to pull the rotor and put it in the OEM shop for “balancing.” Needless to say, the rotor shook badly during startup, at which point the author was called in to deduce that the rotor was significantly unbalanced! Efforts at inplace balancing were rewarded with limited success due to inability to accurately determine the true mode shape of the rotor and inaccessible balance correction planes. This turned out to be a very expensive balance job indeed!

Figure 7. Flexible Rotor With Balance Problems.

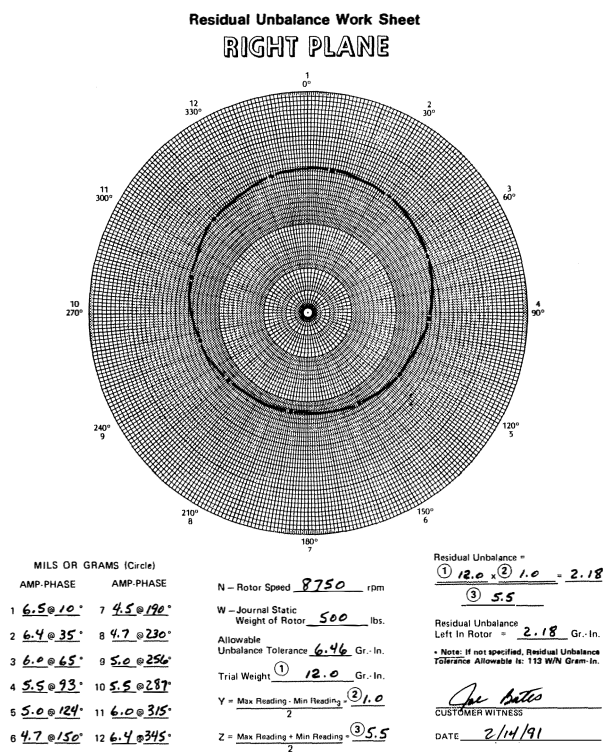
- Mark the rotor off in twelve equally spaced increments (every 30 degrees) for each correction plane.
- Select a trial weight that equals approximately twice the allowable residual unbalance.
- Place the trial weight on the first marked area, then run the rotor up to test speed and record unbalance amount and phase.

- Repeat the preceding step for the remaining eleven positions, being very careful to place the trial weight at exactly the same radius for each run.
- Plot the recorded data on polar coordinate graph paper, and calculate the residual unbalance amount (Figure 8).

Figure 8. Example of Residual Unbalance Test.

The resultant plot should approximate a circle. If not, the most common reason is inaccurate placement of the trial weight during the test. The second most common reason for a noncircular plot is inconsistent machine readouts. A balance machine that will not read out consistently for two identical balance runs cannot be used to accurately balance or to accurately determine residual unbalance. Therefore, consistency of readouts is the most important requirement of any balancing machine.
